# INCLUSIVE STREETS

## Inclusivity in Action

PANAJI

Inclusivity in Action is a synopsis of PULL's work on Inclusive Streets. It highlights the main challenges and recommendations proposed in the Preliminary Report and Implementation Strategy and showcases how these recommendations play out on 18th June Road in Panaji.

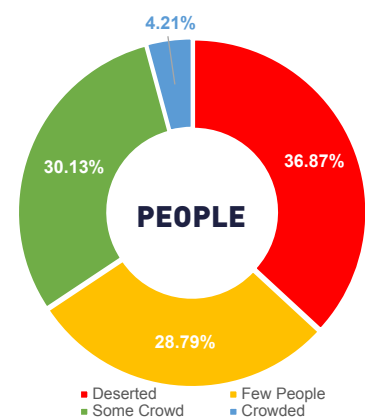
Figures 3 and 4:  
Distribution of Audit scores for the parameters People and Visibility

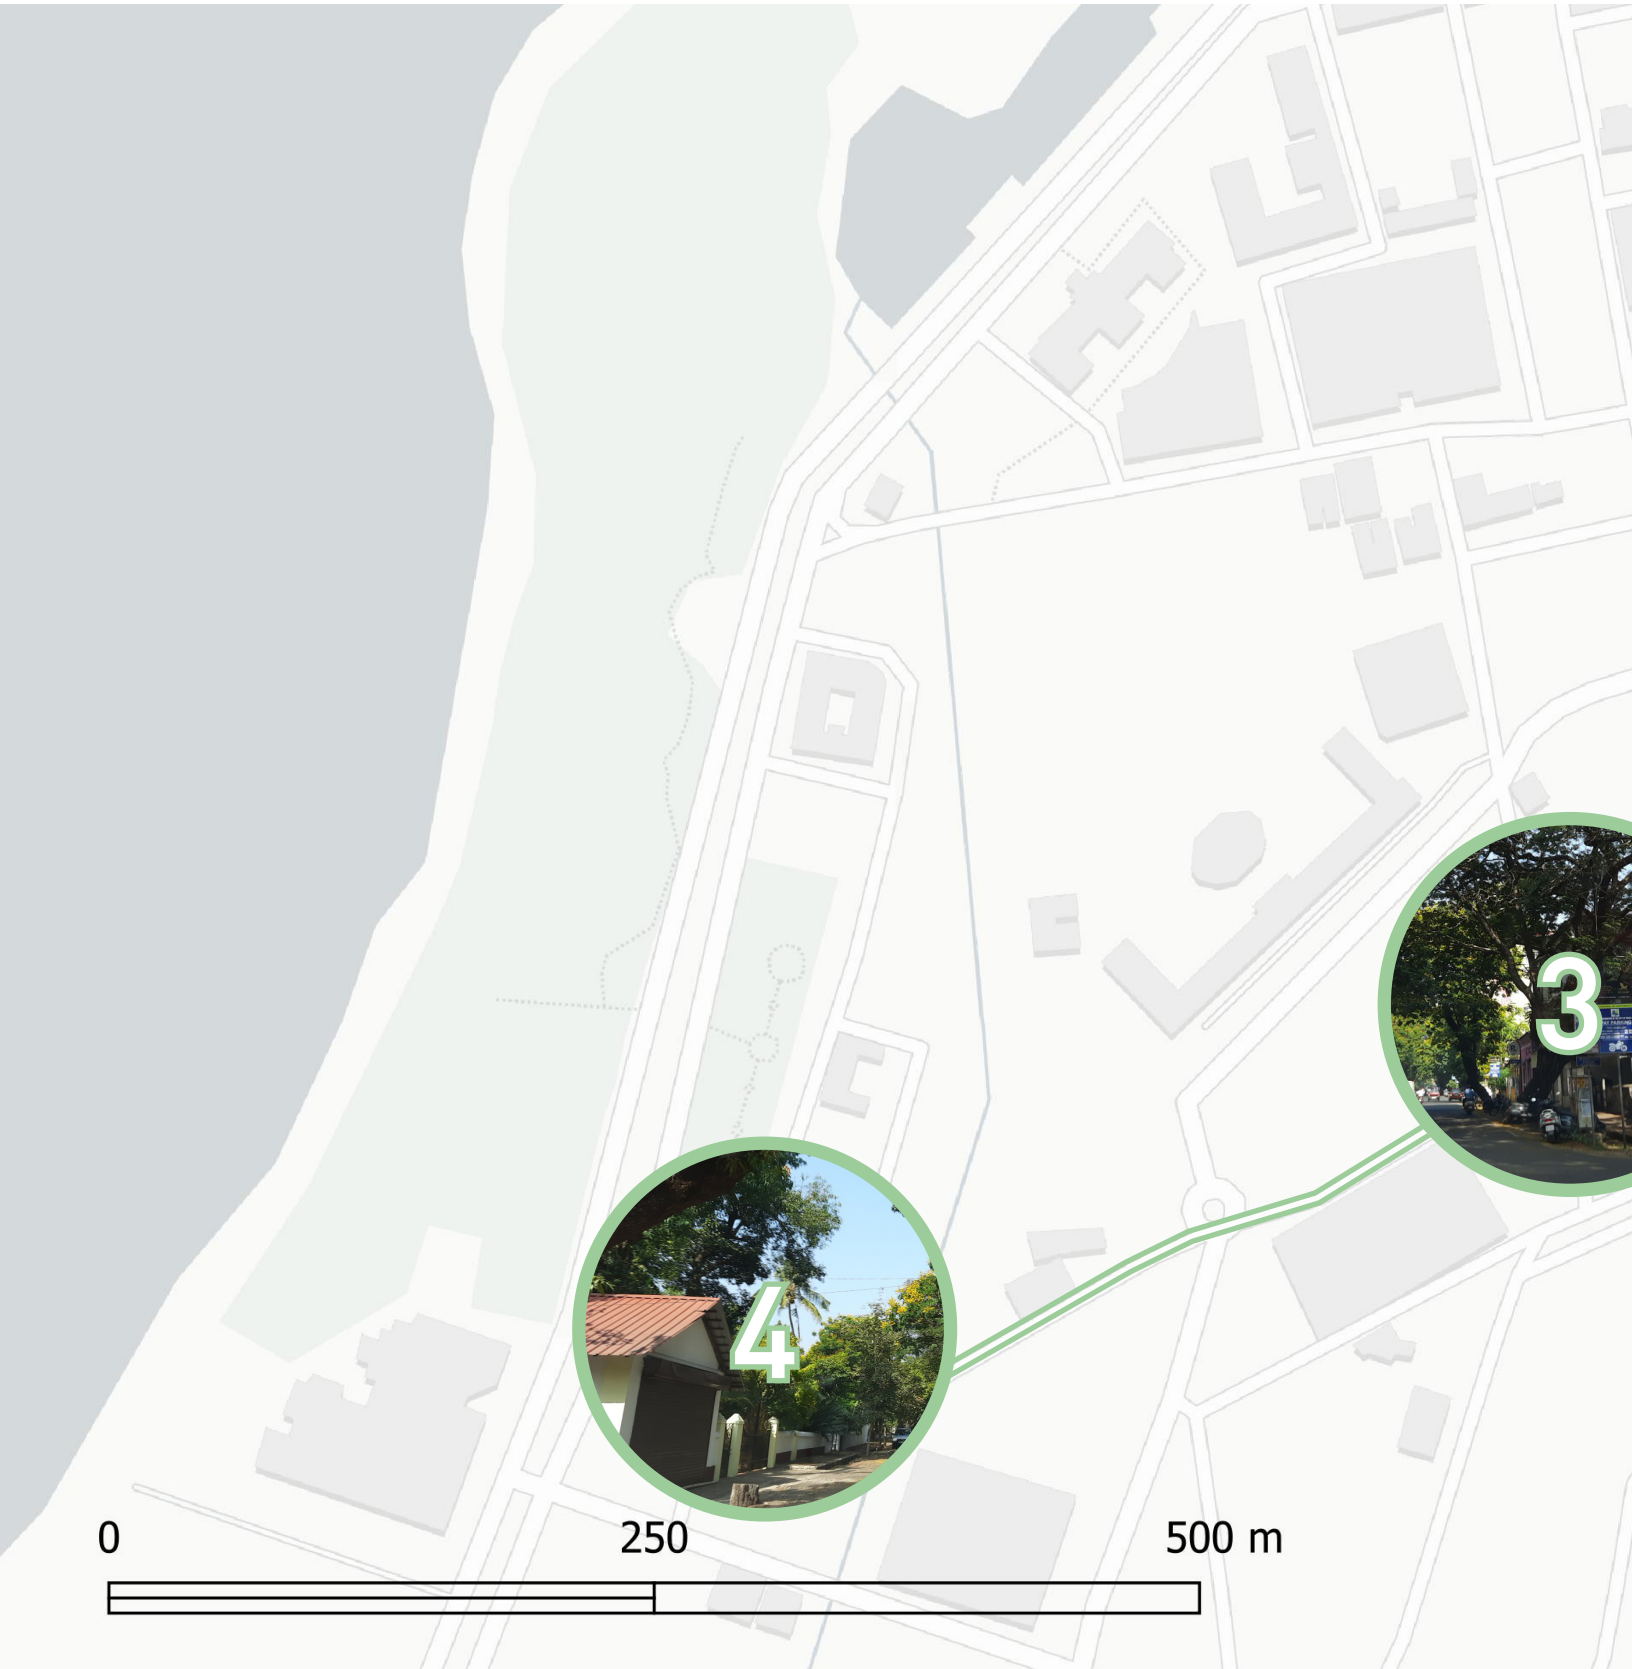
Map 1: Selected Sites for Transformation on 18<sup>th</sup> June Road

This section of the report will highlight how implementing the seven recommendations will create improved access for women of these affected groups. It will demonstrate the improved experiences of three women: **Joanne**, **Maria** and **Varsha** on various stretches of 18th June Road (please see Map 1 on page 10).

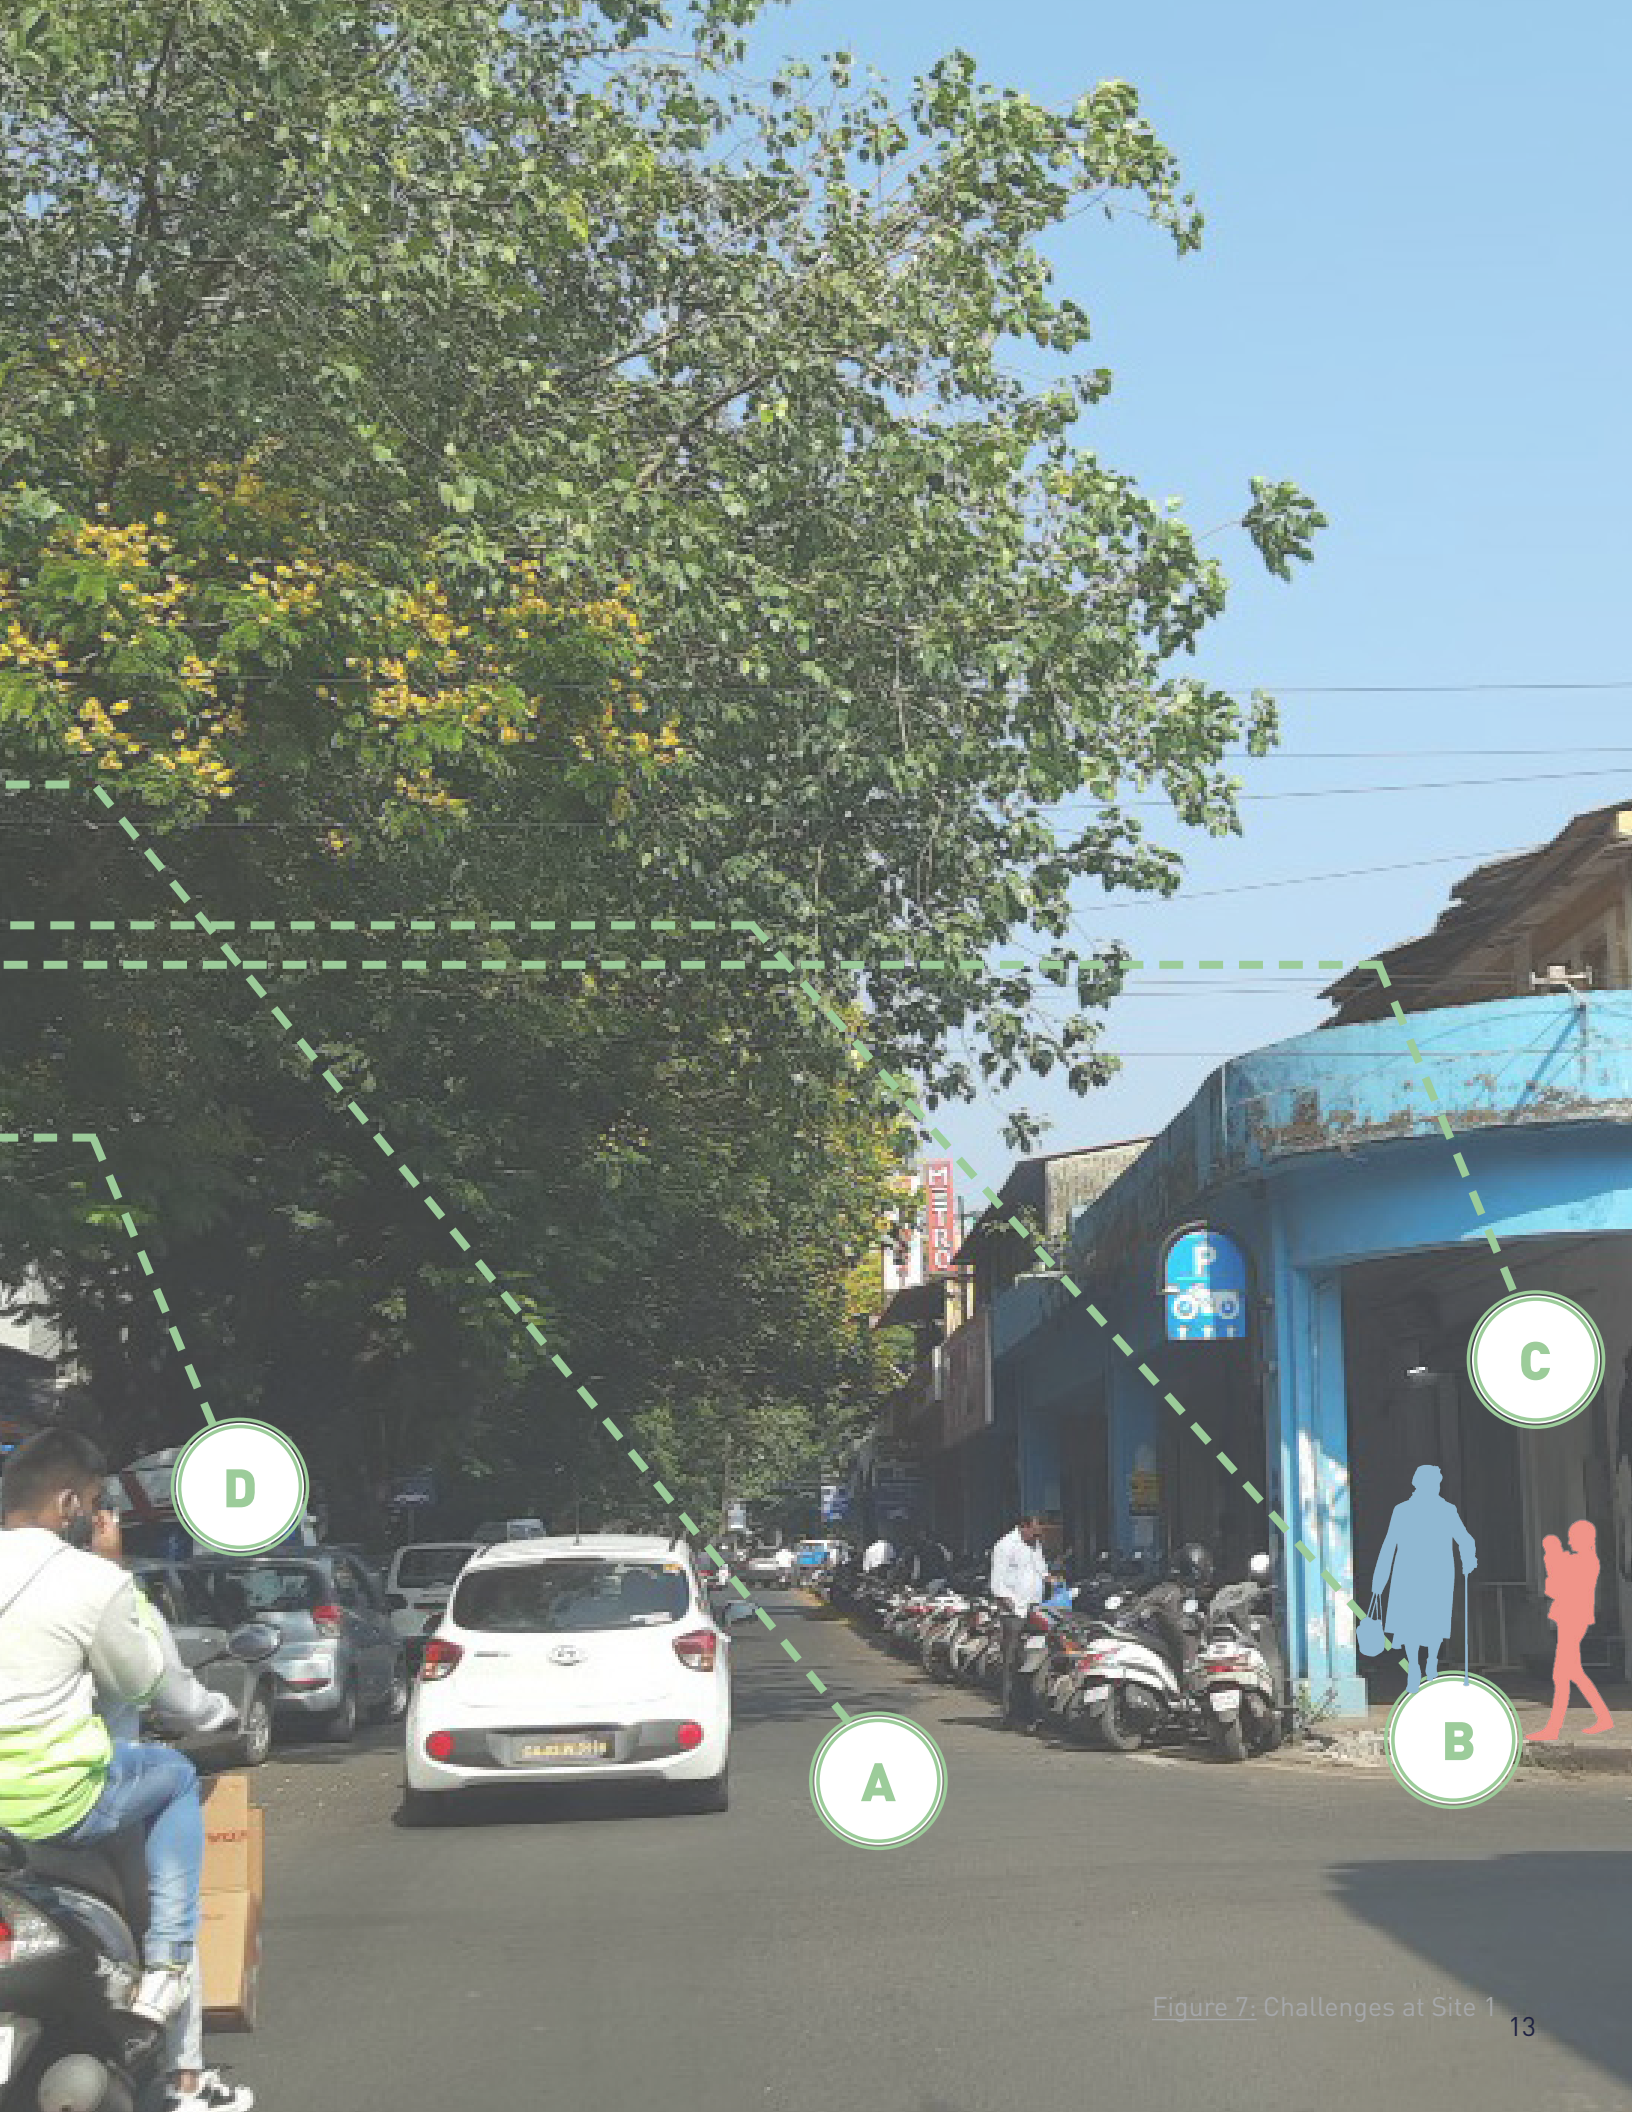
Figure 7: Challenges at Site 1

Joanne walks from her home to the Urban Health Centre on 18th June Road for a doctor's appointment. With **no designated crossing space** or signalised intersection, she has to wait for vehicles to pass to cross the street. As it gets dark, she is worried about being able to see the **raised kerb** without enough **street lighting**.

When Varsha brings her son to the market to run some errands and do her shopping, she has to carry him. While one side of the road has space to enter the walk path, the other is **blocked by parked vehicles, making it nearly impossible for her to fit between them** to get to the stores.

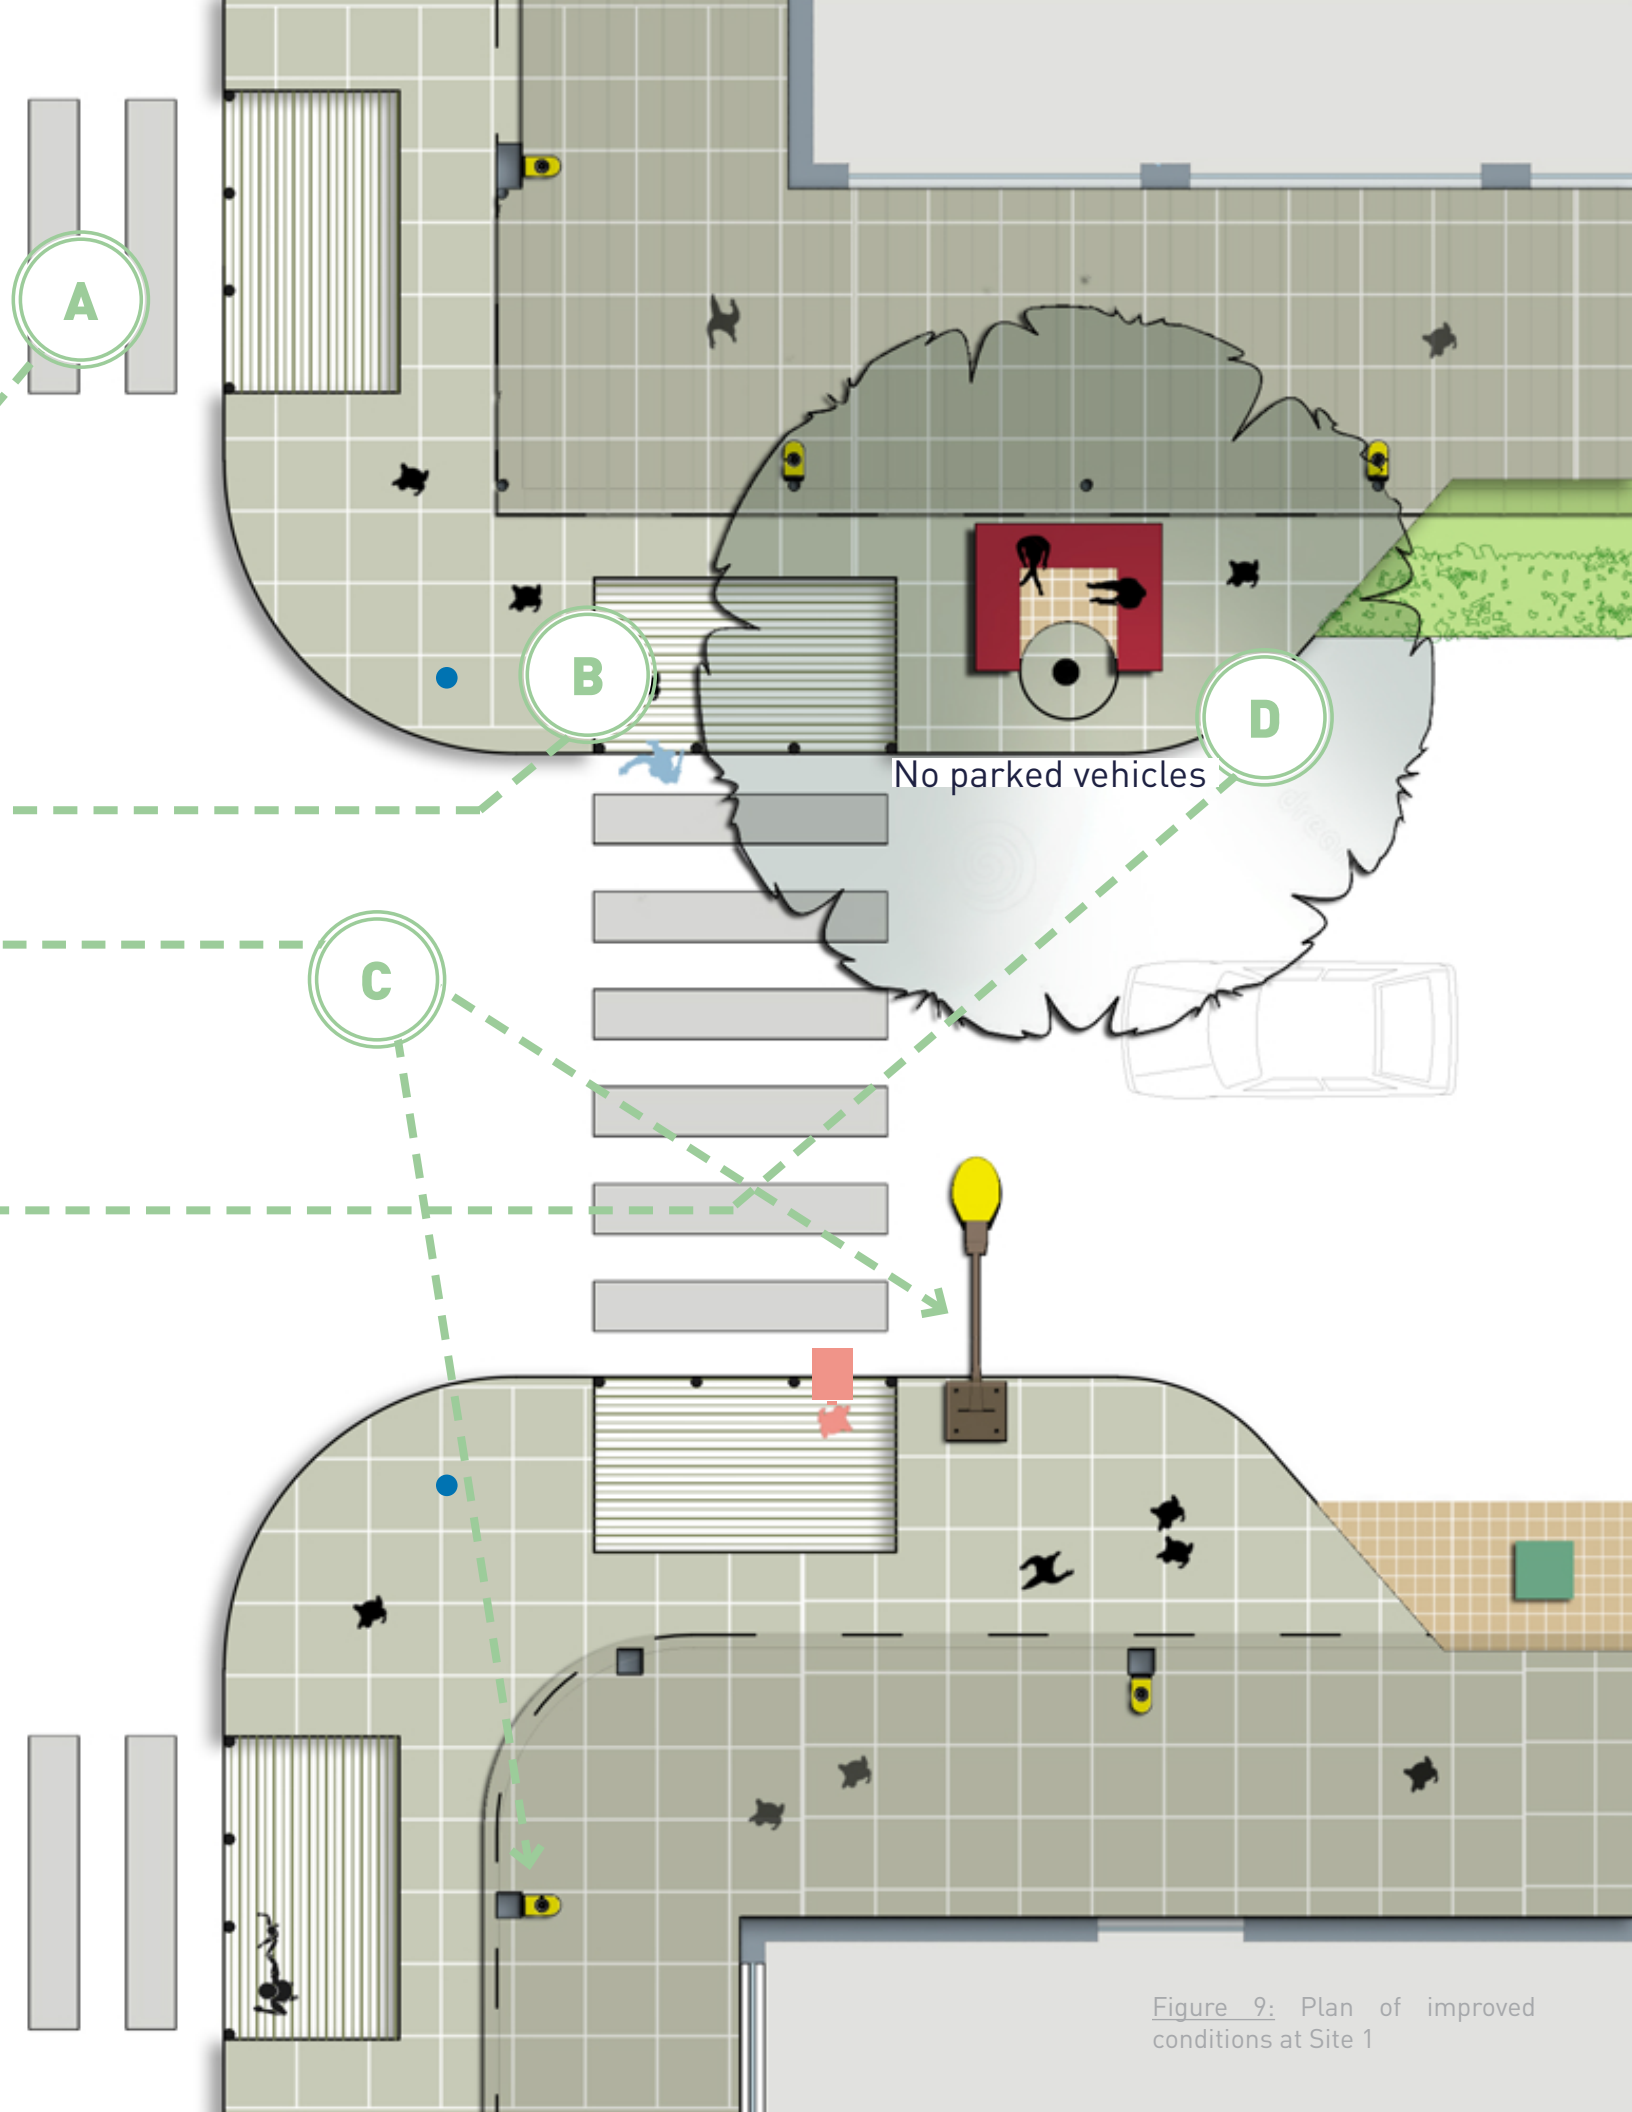
Figure 9: Plan of improved conditions at Site 1

When **Joanne** goes for her next check-up, she finds that the intersection has been redesigned: new **wide and well-marked zebra crossings** make it easy for her to cross the street without worrying about oncoming traffic; **ramps at the ends of the crosswalk** enable her to easily access the walk path without searching for a gap between parked vehicles. In the evening, she is able to see well with newly **installed lighting**.

Next time **Varsha** goes shopping, she brings her son in a pram, as it is easy to access the walk path with newly installed ramps. The **walk paths have been widened** and **parked vehicles no longer block entry points** onto the walk paths marked with bollards to **prevent vehicular encroachment**.

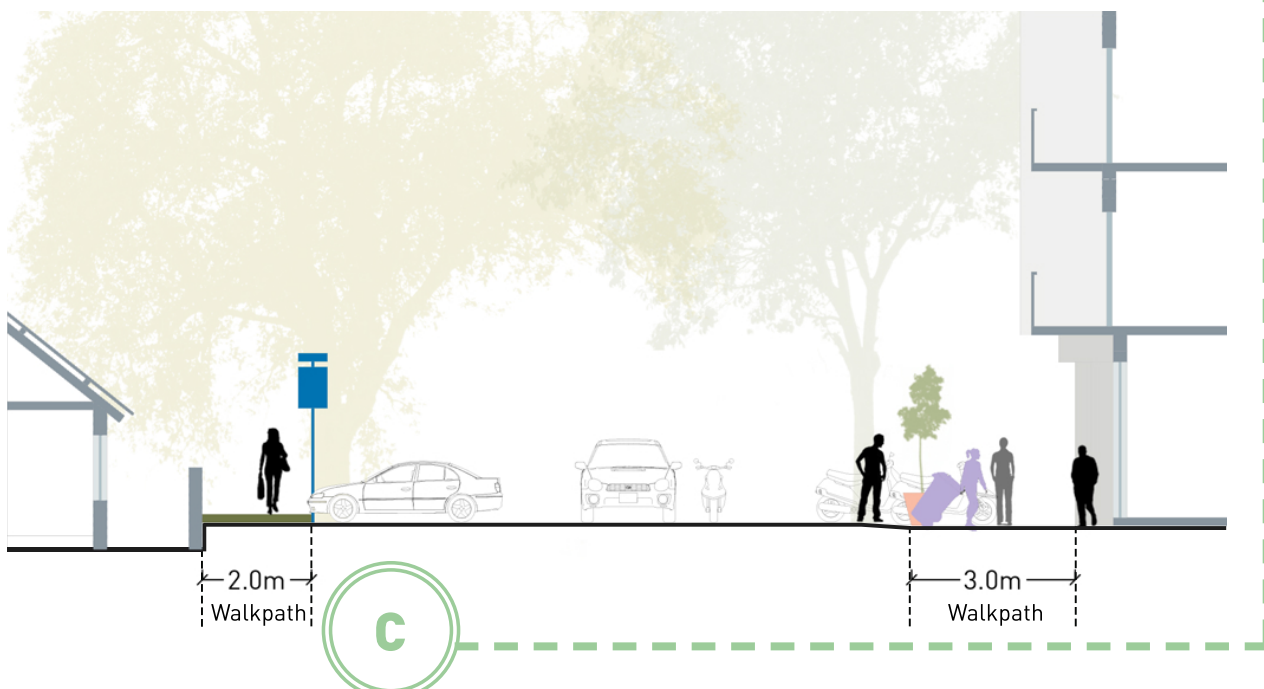
While collecting garbage from both the residences and commercial establishments on the street, **Maria** struggles to pull her garbage bin onto the walk path due to the **broken kerb or parked vehicles**. As there is **no mid-block crossing**, she risks oncoming traffic when she crosses the street. Then she has to find a gap between parked vehicles to leave her garbage bin as she goes to the adjacent buildings, as the **walk path is too narrow** to allow her to pull the bin.

Figure 10: Section of existing conditions at Site 2

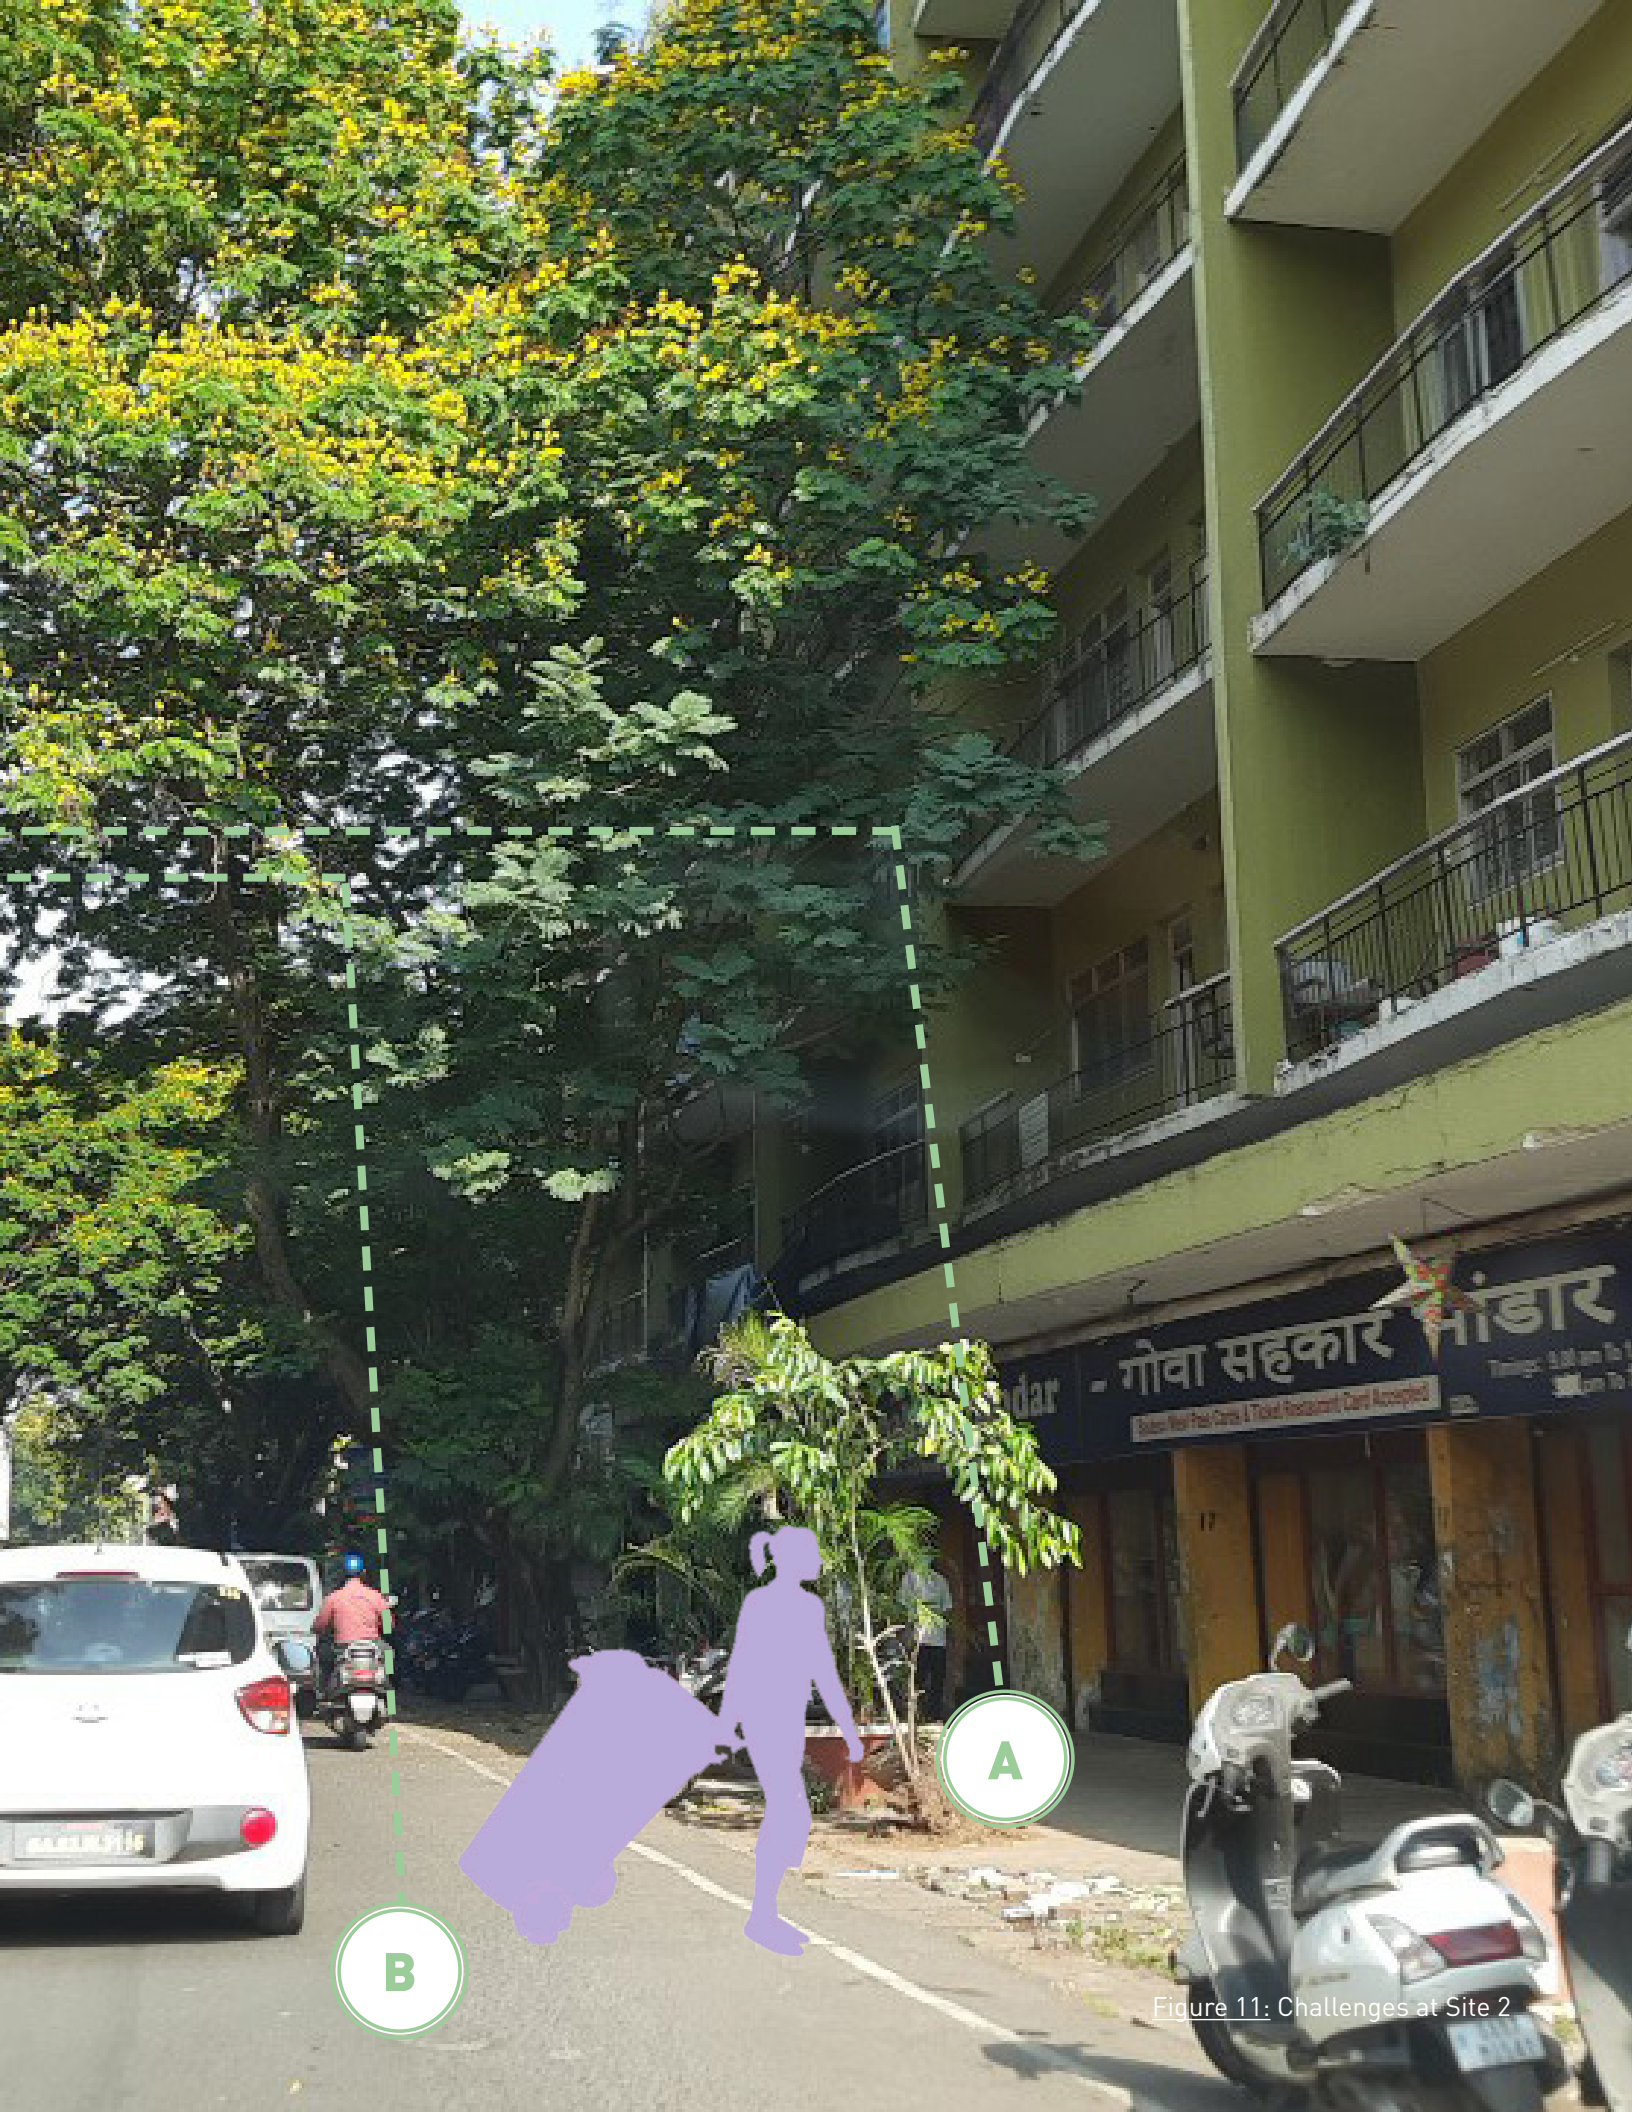
Figure 11: Challenges at Site 2

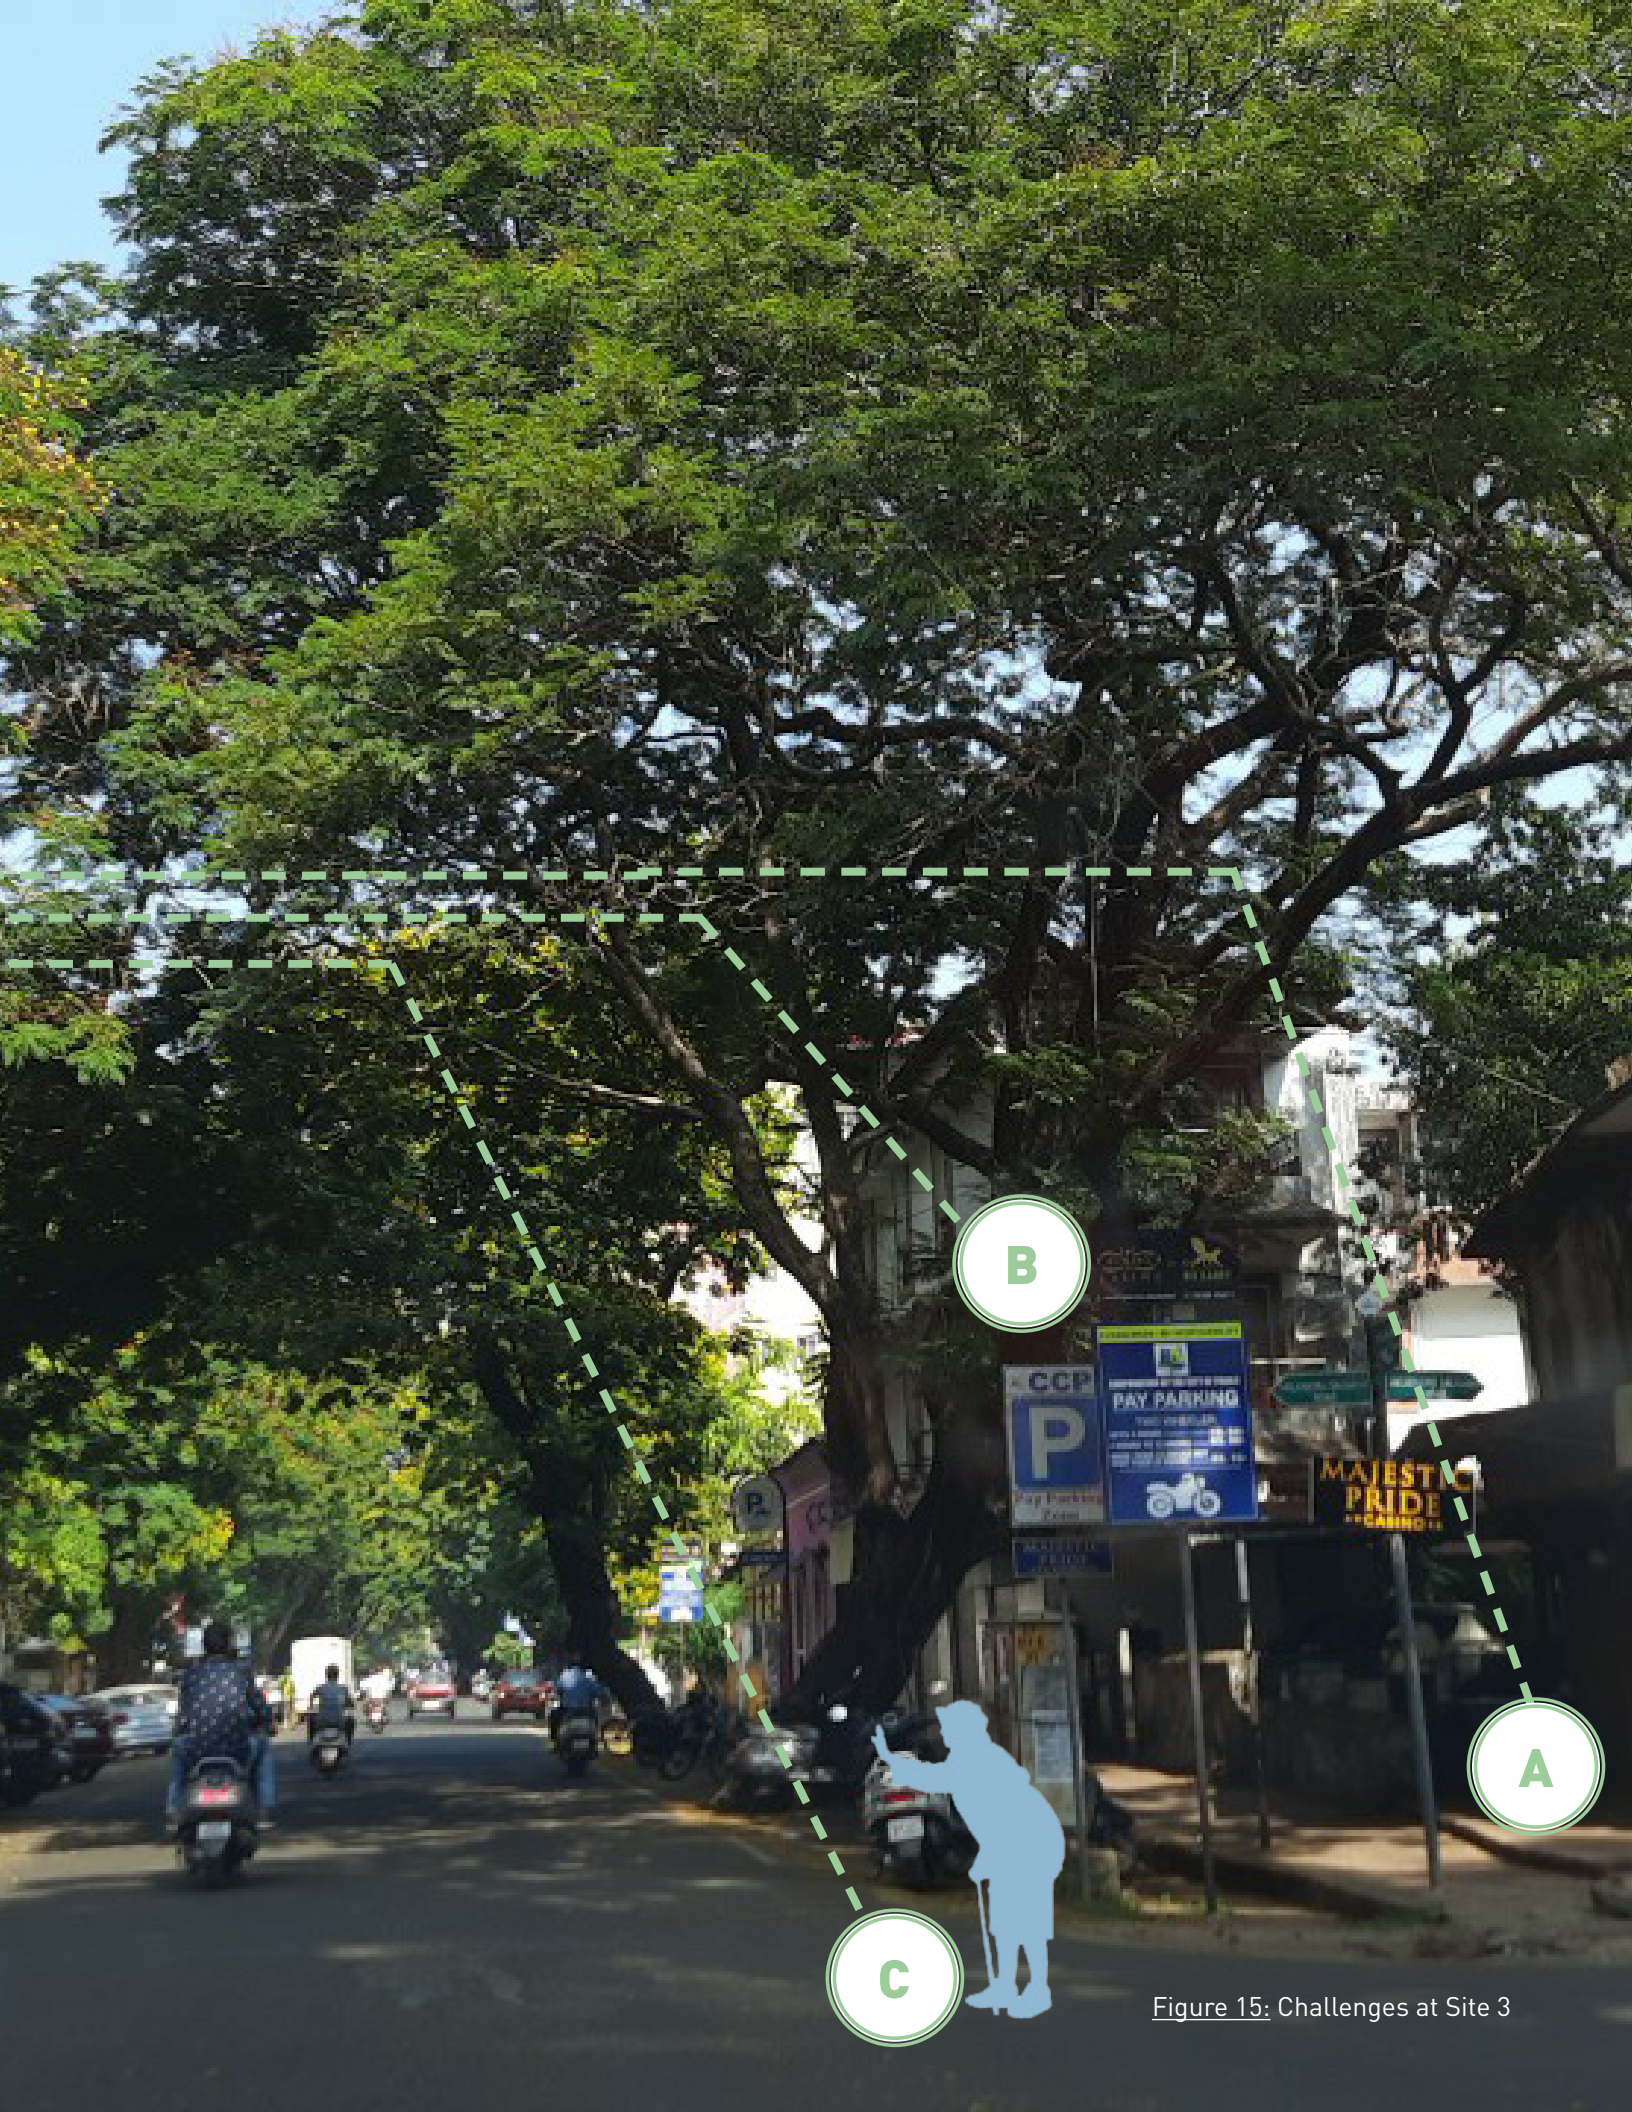
Figure 15: Challenges at Site 3

Before going home in the evening, **Joanne** stops at the Canara Bank. After the long walk, she is quite tired but has nowhere to rest. In the monsoon, she is worried about slipping given the **uneven pavement surface**, broken kerbs and **obstructions in the form of poles**. She also worries about rushing to cross the street as there is **no zebra crossing** at the junction.

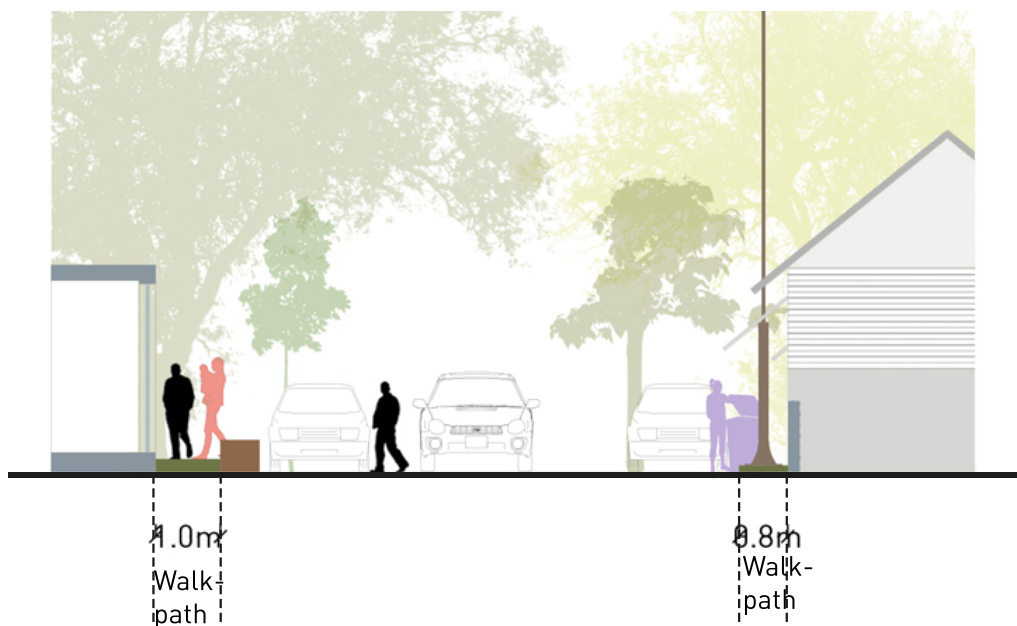
**Maria** crosses this area early in the morning while collecting garbage. On winter mornings, the **walk paths are dark** as the street lights are focusing on the motorized carriage way and not on pedestrian areas, which makes her worry about tripping over **obstructions like garbage** that are piled on the walk path. The road is also lined by **blank boundary walls**, making the space feel isolating and lonely.

When **Varsha** is walking home from the market, carrying her son and shopping bags, she is tired but has **nowhere to rest**. The **narrow walk paths** make it difficult to walk so she must walk on the road, increasing her risk of an accident.

Figure 18: Section of existing conditions at Site 4

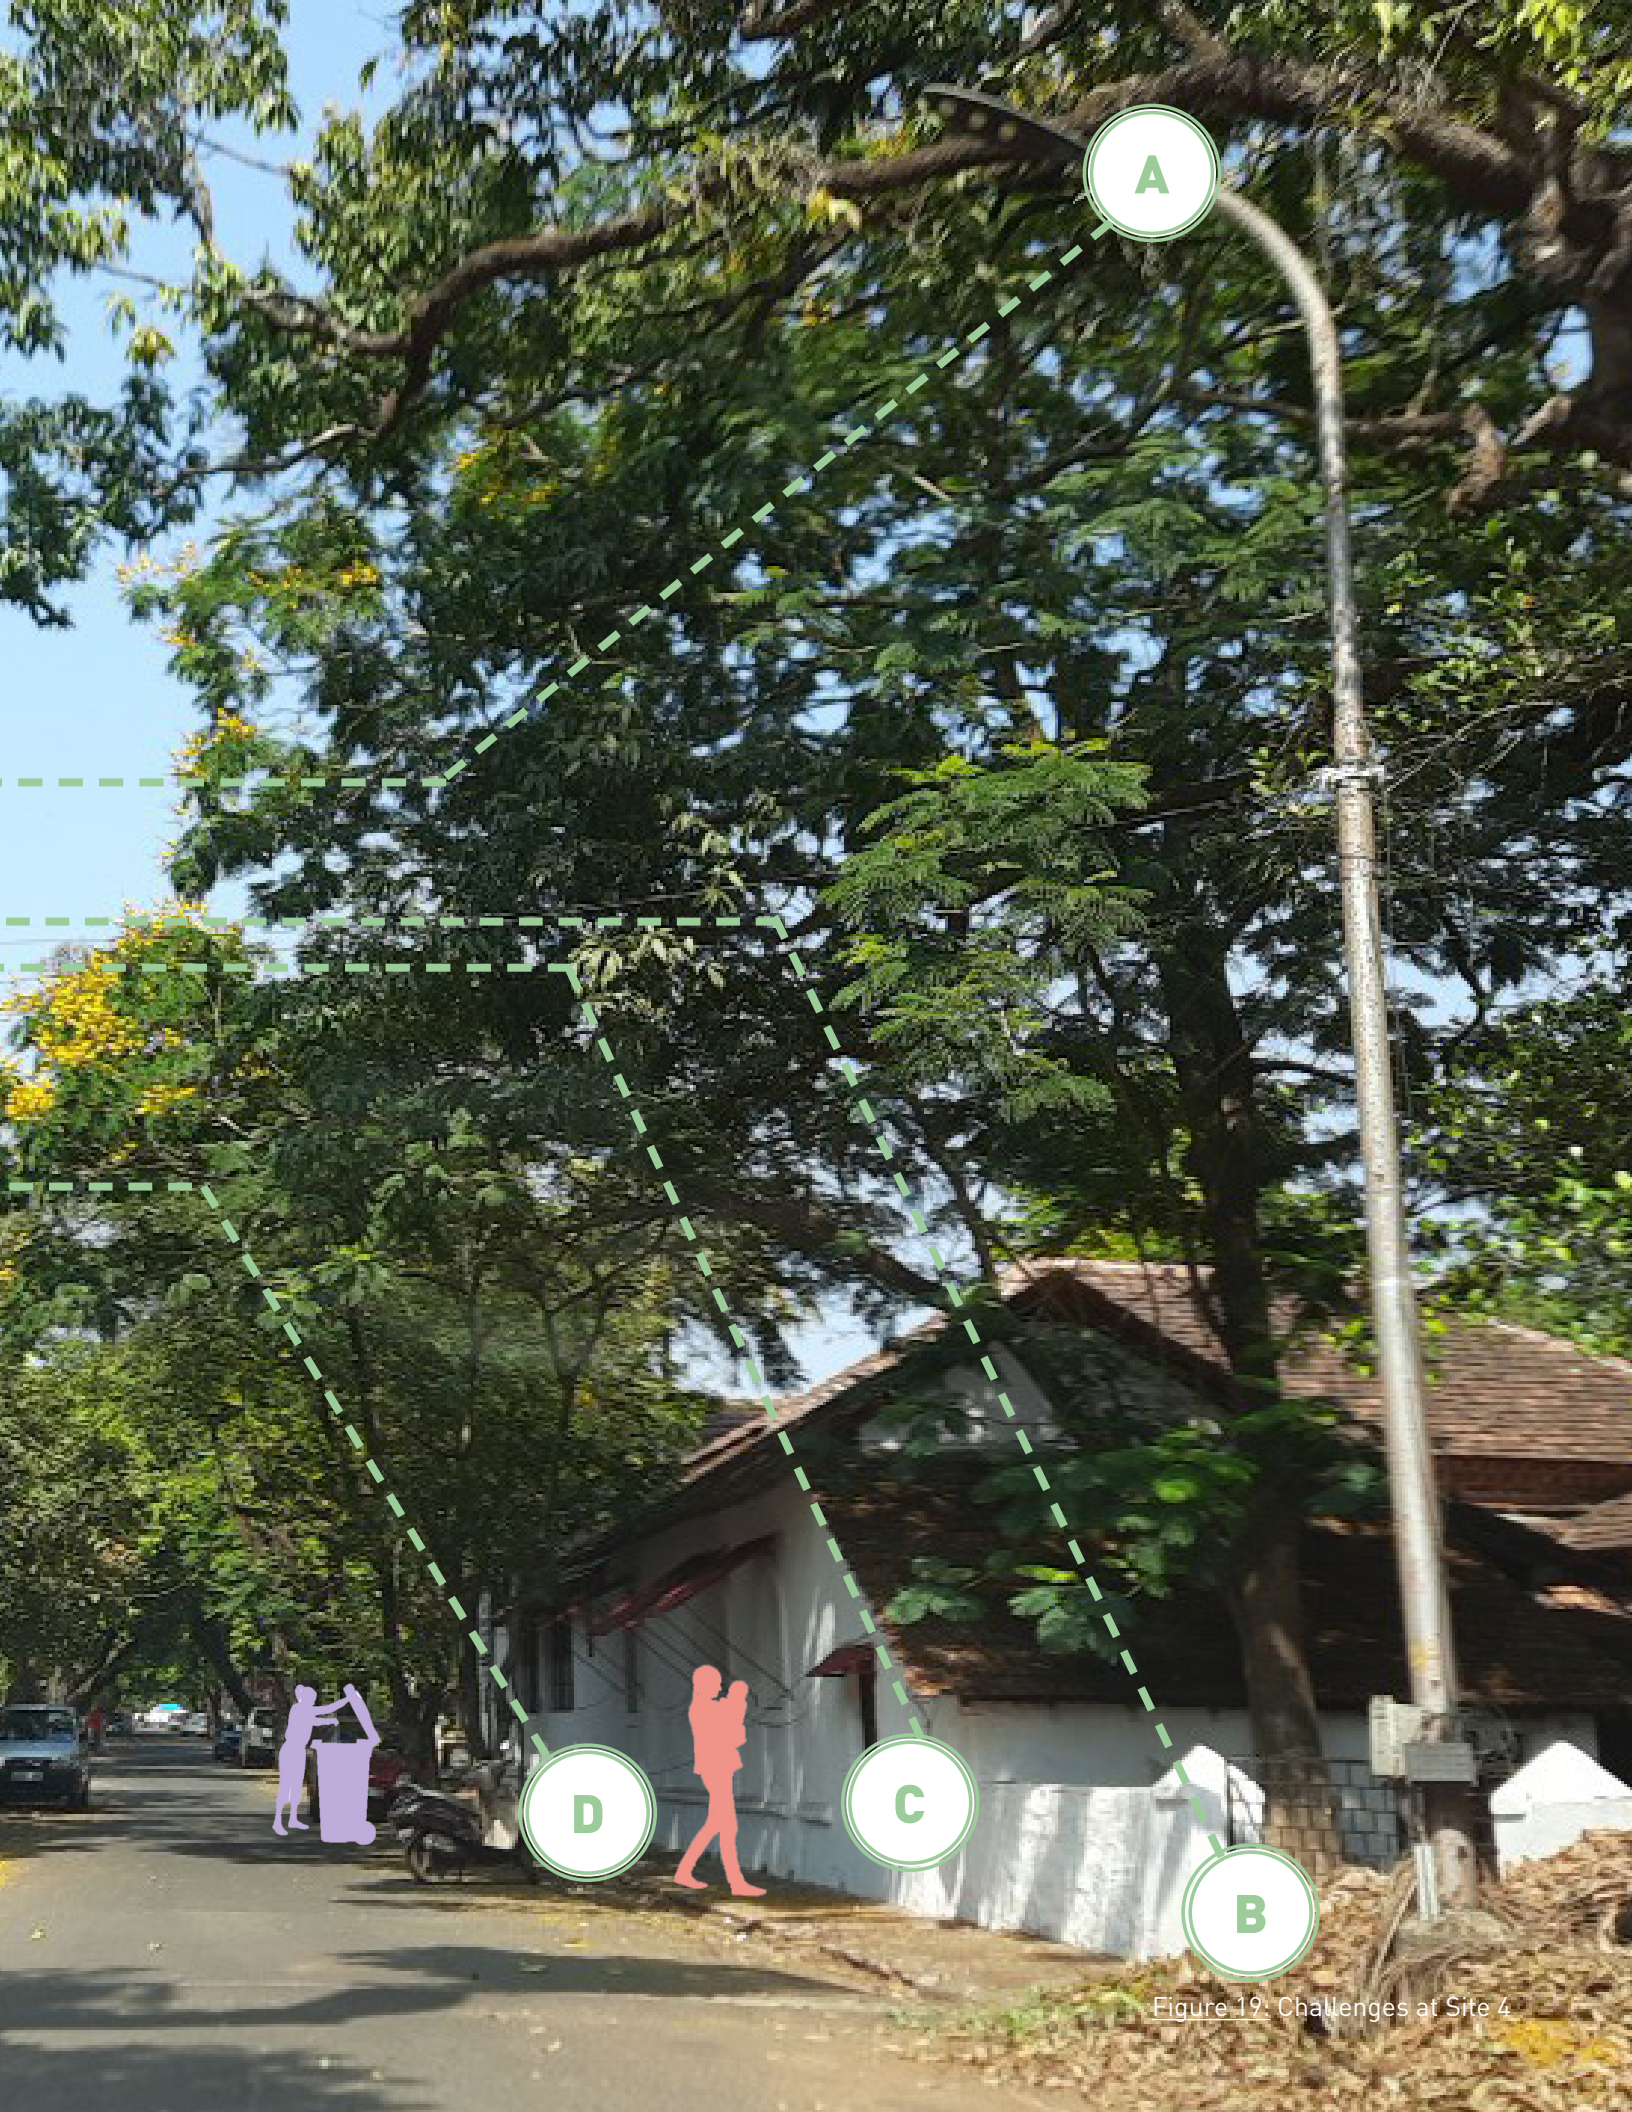
Figure 19: Challenges at Site 4
